**FORT DEVENS
FINAL REMEDIAL
INVESTIGATION
FOR GROUP 2 & 7 SITES**

**FINAL
REMEDIAL INVESTIGATION REPORT
AREA OF CONTAMINATION (AOC) 41**

February 1996

**ABB Environmental Services, Inc.
Portland, ME
Project No. 07053-15**

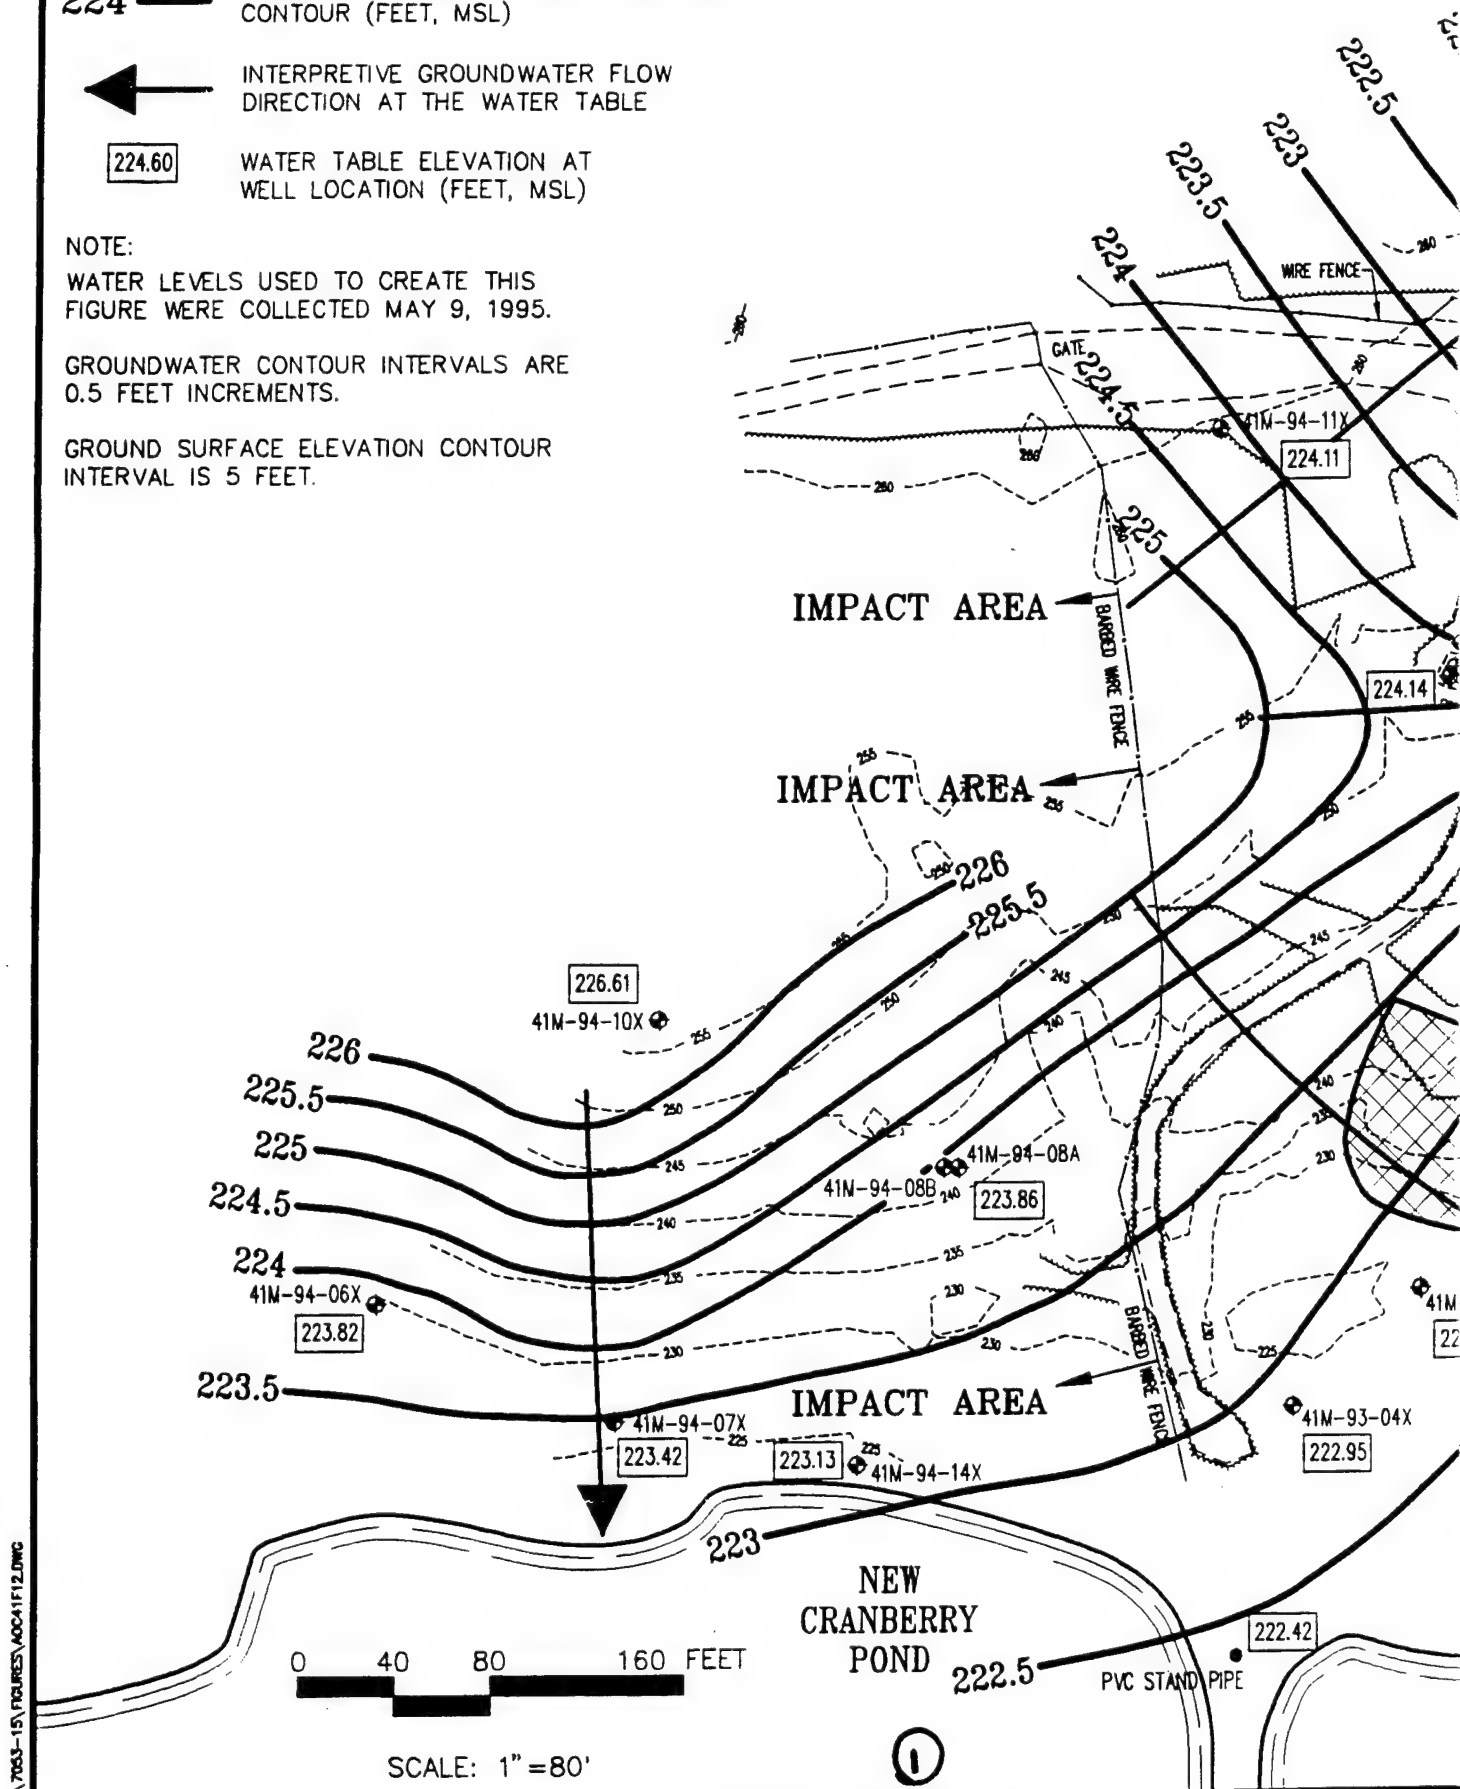
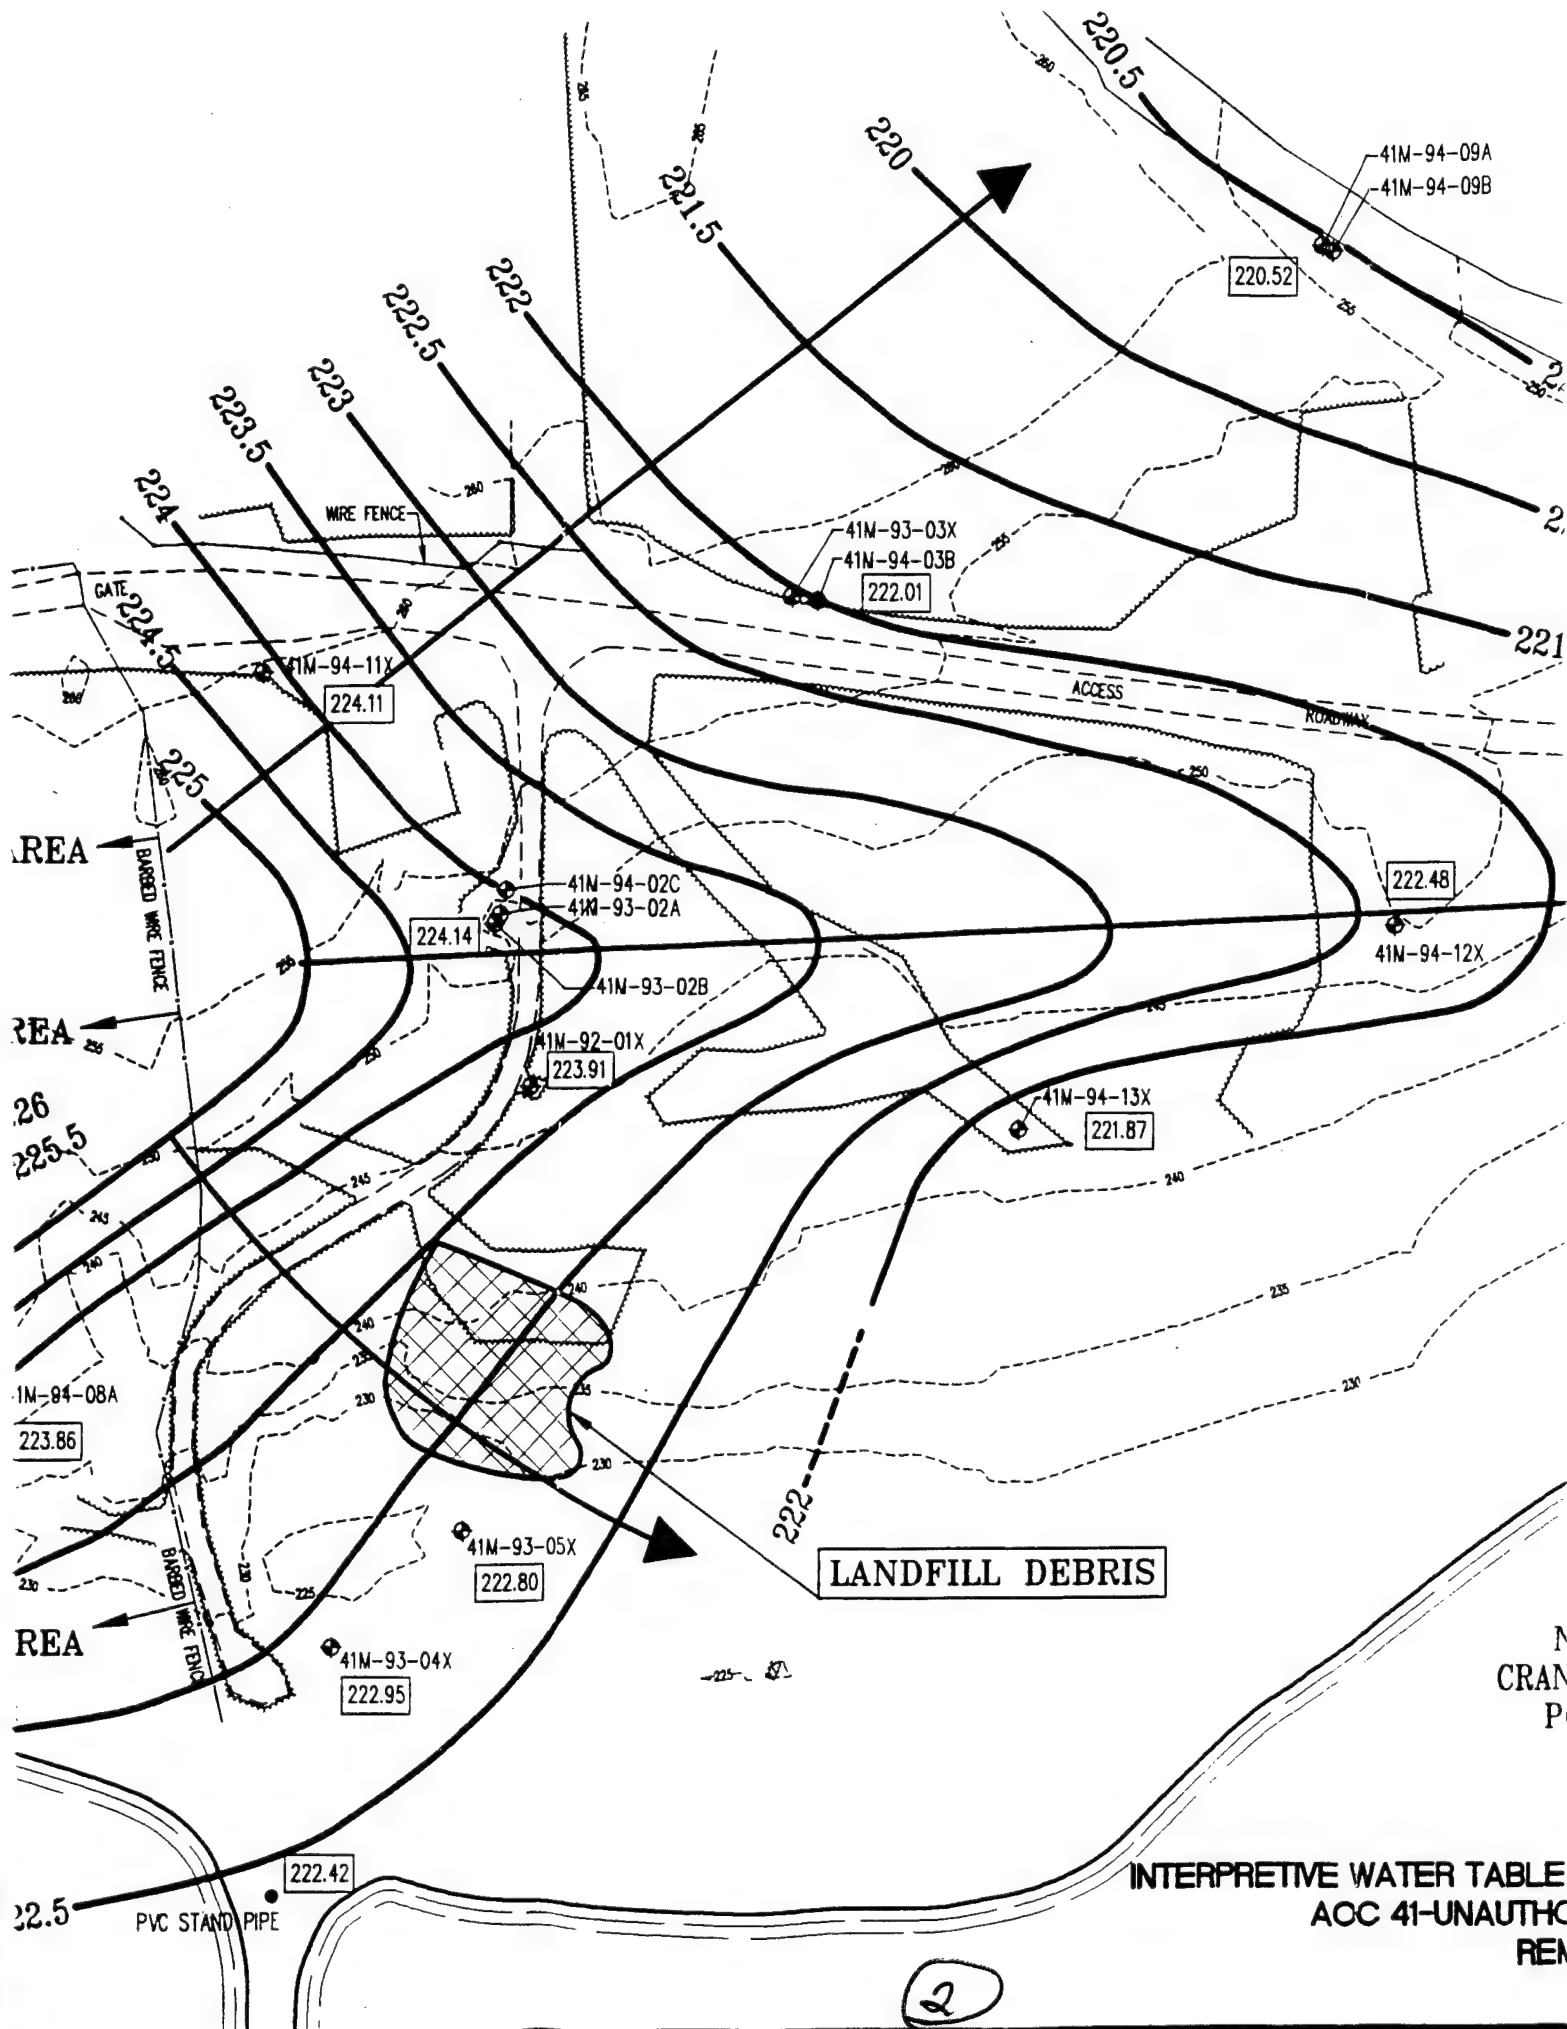
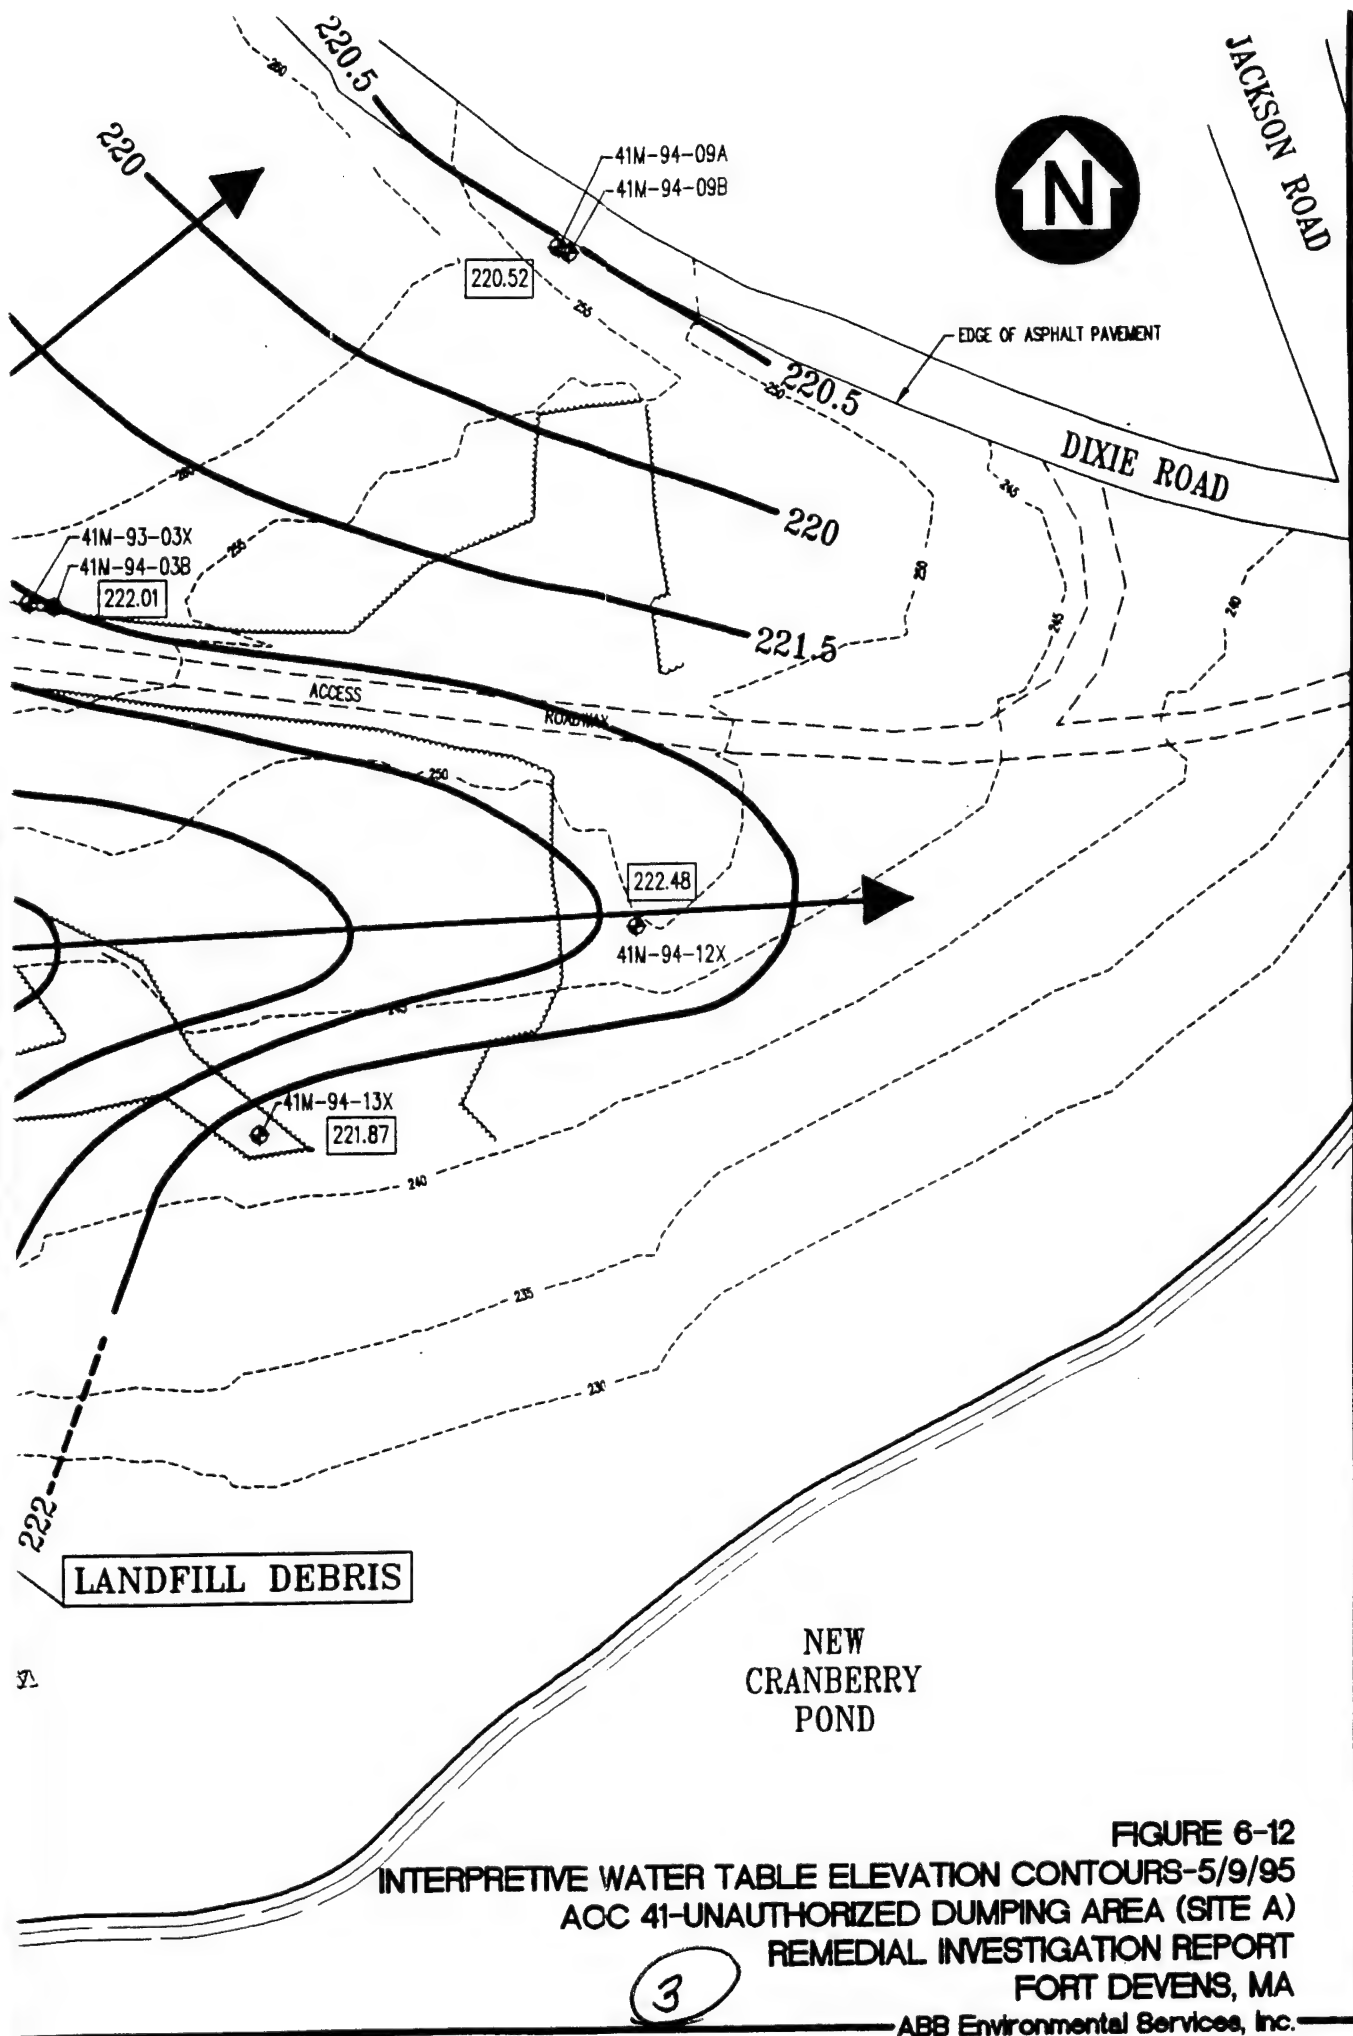
FIGURE 6-12
INTERPRETIVE WATER TABLE ELEVATION CONTOURS-5/9/95
ACC 41-UNAUTHORIZED DUMPING AREA (SITE A)
REMEDIAL INVESTIGATION REPORT
FORT DEVENS, MA

GROUNDWATER CONTOUR INTERVALS ARE 0.5 FEET INCREMENTS.

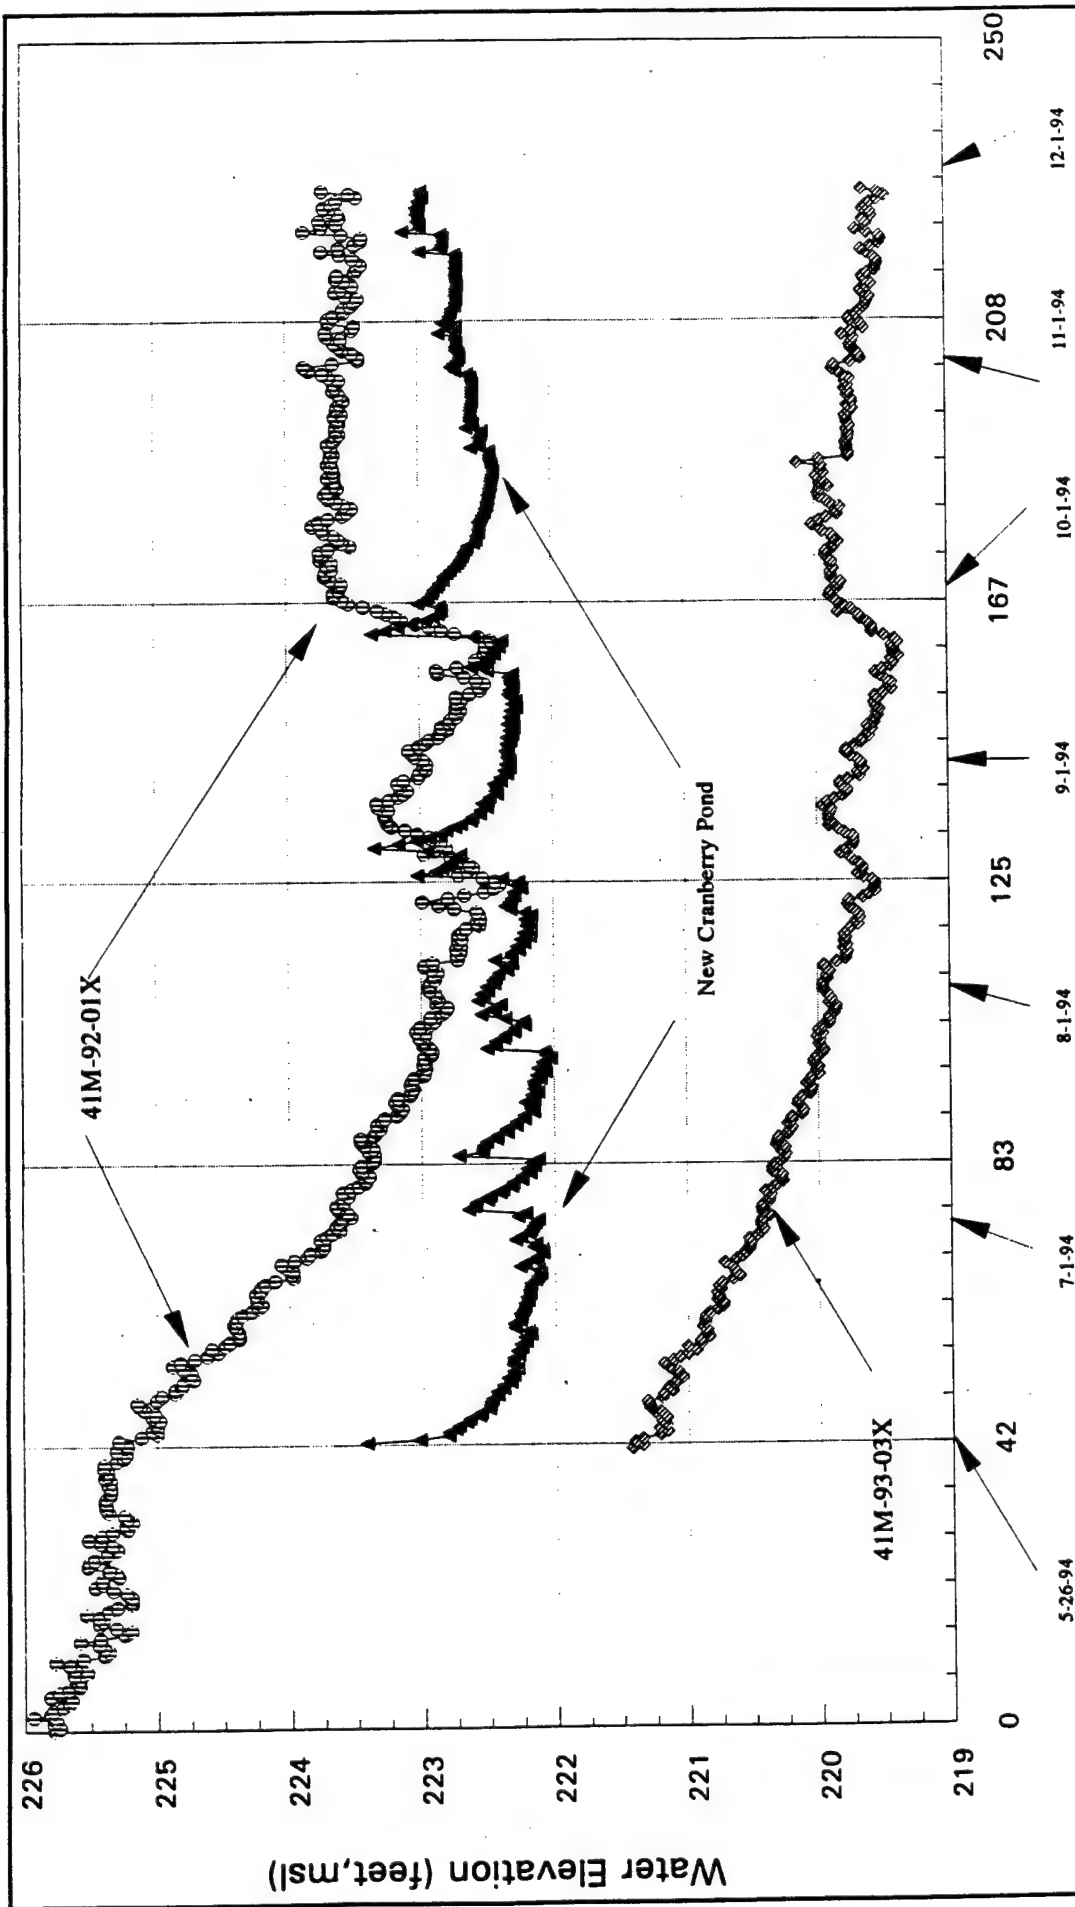
FIGURE 6-14
LONG-TERM WATER LEVEL MONITORING
AOC 41-UNAUTHORIZED DUMPING AREA (SITE A)
REMEDIAL INVESTIGATION REPORT
FORT DEVENS, MA

Time in Days Since 1500 hrs on 4-14-94

During the course of the previous investigations, it became apparent that the relationship between the water level within New Cranberry Pond had an impact on local groundwater flow. Also, the lag time between the pond variations and those observed in monitoring wells at the site were important. Therefore, a long-term water level monitoring program was initiated prior to the beginning of the RI field investigation. On April 14, 1994 a pressure transducer and In-Situ Hermit™ Well Sentinal data logger were installed in 41M-92-01X, and water level measurement recording began. On May 26, 1994 two additional pressure transducers and similar data loggers were installed at 41M-93-03X and at a PVC well screen standpipe on the north shore New Cranberry Pond (see Figure 5-4). The data loggers recorded data uninterrupted from each measurement point until December 1, 1994. The data recorded is presented in Appendix D-3.
